MythBusters

In the land of PLC, part 2

PLC splitters are passive devices for optical power distribution, manufactured using planar processing methods and used as main components in fiber-optic access networks such as PON. Until recently considered rather exotic, PLC splitters are now gaining popularity among operators and installers due to the spreading of PONs. The popularisation of PLC splitters is caused mostly by the decrease in their pricing as well as the increase of the suppliers introducing these splitters to their offer. At the moment, PLC splitters became so popular that many operators began to consider them as mass-produced and widely accessible devices, so simple they cannot be malfunctioning. With such an approach the only matter that should be taken into account when selecting the supplier is obviously the price. Is this justified? In this series of articles we shall be exploring the most important myths regarding the splitters. It is time for the second part of our mini-series, dedicated to the aging of PLC splitters.

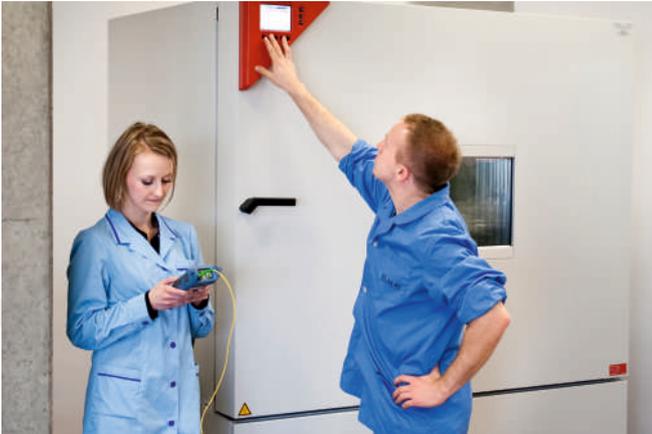
FIGURE 1 – The A-Team is arming the Death Star

We put all ten Xyyyy-branded 1x32 splitters into the **chamber** (the same splitters that we used to verify Myth 2). The testing procedure consisted of good old temperature cycles as per the European norm IEC 61300-2-22. Now comes the moment of truth (actually 3 temperature cycles were sufficient, instead of the normally required 12 cycles) – **7 of 10 tested splitters increased their attenuation significantly** (depending on the specimen, between 2 and more than 7 dB). The results for one of these 7 splitters are shown in Fig. 2.

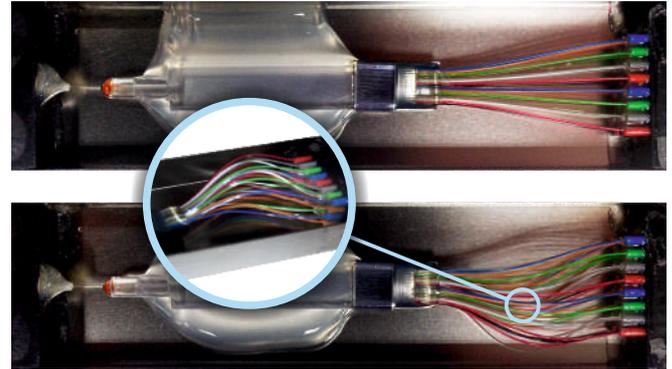
FIGURE 3 – Xyyyy-branded 1x32 splitter containing the correct amount of adhesive before (above) and after (below) testing in the environmental chamber. A receding fiber and macrobendings are evident.

It may seem comforting that at least three splitters have not increased their attenuation and passed the test, right? Well, not really, as they simply **broke the casing apart** – fibers receded into the housing in low temperatures and pulled the boots out. What to choose of those two evils? In the Fig. 3 we can see one of the splitters, which was unlucky enough to have its boots strongly glued into the housing, so the glue held and macrobends resulted. For comparison, Fig. 4 presents its compatriot (from the same batch) which was given less love (we mean less adhesive) – it managed to break free from his cage.

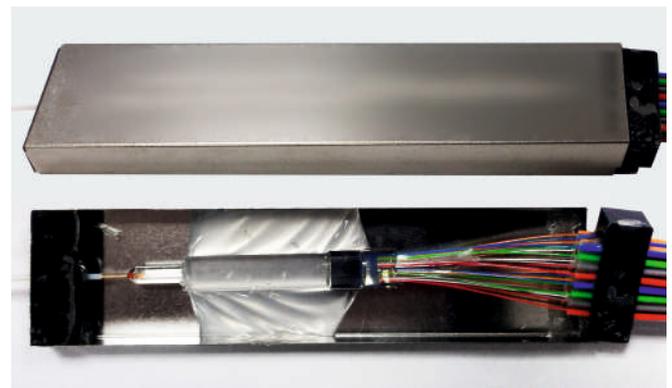
FIGURE 4 – Xyyyy-branded 1x32 splitter containing the insufficient amount of adhesive after testing in the environmental chamber.

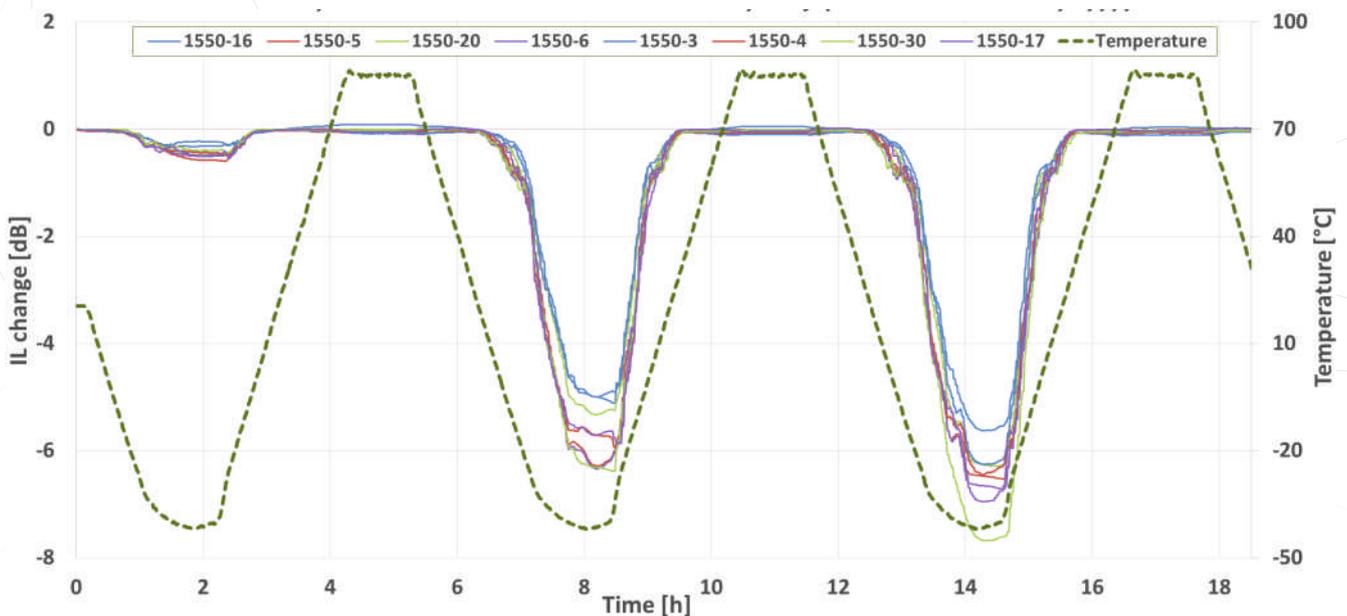
FIGURE 2 – A sample Xyyyy-branded 1x32 splitter vs. the environmental chamber – changes in attenuation by approx. 8 dB are evident.

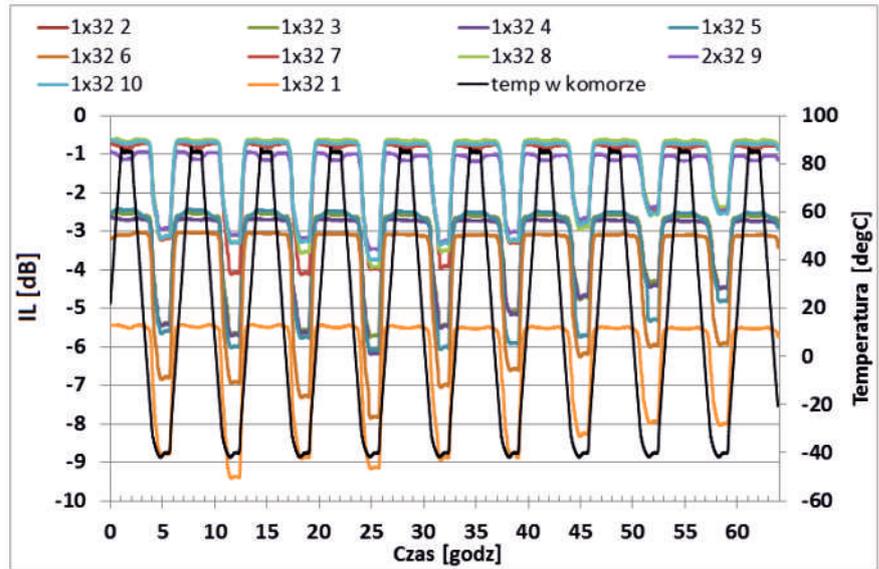
FIGURE 5 – Changes in insertion loss value for selected ports of AAA-branded 1x32 splitter during testing in the environmental chamber – fluctuations in attenuation value from 3 up to 9 dB

To make sure everyone is treated fairly and equally, we have also tested the 1x32 splitter from the AAA supplier (mentioned in the part 1 of our trilogy) under the same conditions. Frankly speaking, this individual was way more interesting, as every single output exhibited a different behaviour after being subjected to temperature – the attenuation varied between 2.5 and 9 dB (as shown in the Fig. 5).

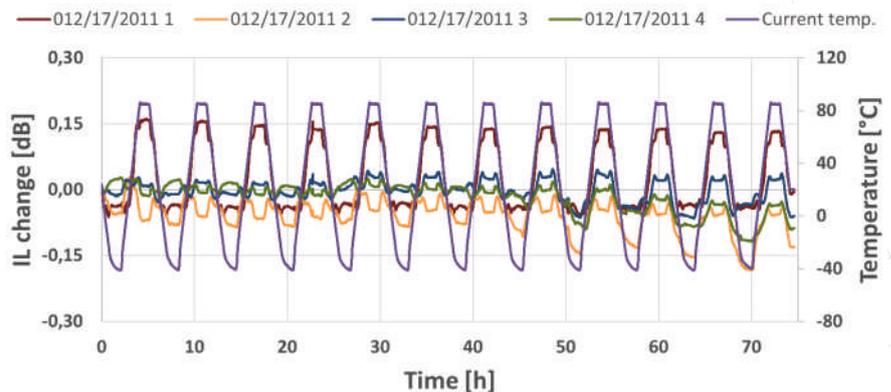
FIGURE 6 – Changes in insertion loss value for selected ports of Fibrain 1x8 splitter during testing in the environmental chamber

If you already feel down that surely your network will very likely die in the next semi-frosty winter, worry not, **for there indeed are PLC splitters that can work in the full temperature range of -40 to +85 °C!** To prove this bold claim to you, we present in Fig. 6 the changes in insertion loss vs. temperature for a Fibrain 1x8 splitter. Under extreme temperature conditions the attenuation varies by no more than 0.2 dB. As we can see, stable splitters are possible to achieve, though not easy to come by.

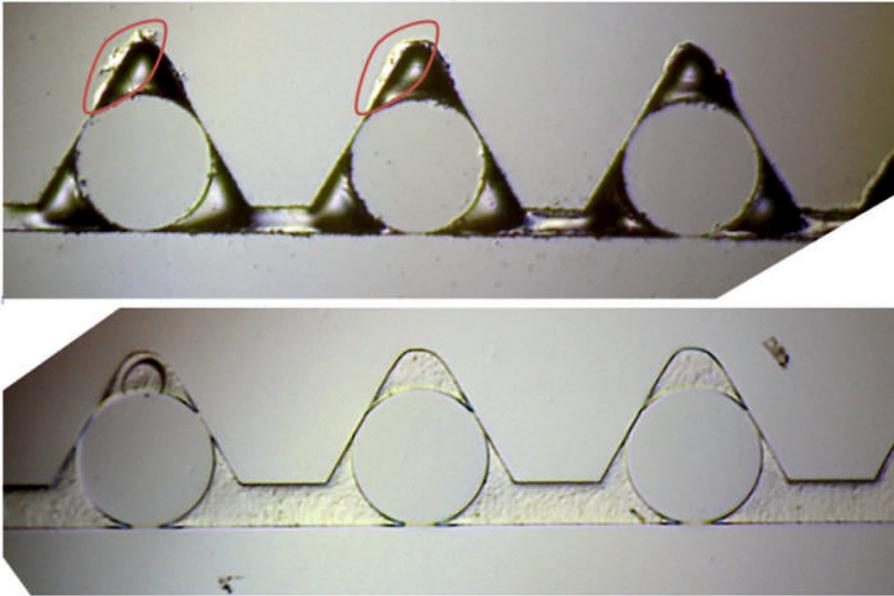
FIGURE 7 – The influence of humidity on fiber array elements coming from various producers.
The areas of delamination, marked red, are evident in the photography above

It is evident that the adhesive in the fiber array element coming from the Fibrain splitter (below) has not been damaged, while the other module (above) shows signs of bond losses and delamination. This type of degradation leads to the movement of fibers (which normally should be fixed in V-grooves), and in effect to power fluctuations, especially when the splitter is buried by railway tracks. An interesting fact for those having their networks in rural areas is that the degradation of most adhesives is significantly faster in acidic environment (caused e.g. by the usage of fertilisers).

Good quality (and expensive) epoxy adhesives for photonic applications must pass strict stability and durability tests according to Telcordia requirements (there are also many other parameters involved, such as matching refractive indexes and high optical power resistance), unlike the cheap substitutes. Let's demonstrate this point. Our laboratory team submerged the fiber array modules from Fibrain splitters and from the suspiciously cheap splitters purchased online **in water at 40 °C for a period of three weeks**. Fig. 7. shows the results of this experiment.
